Inspection Notice on the ISC KH260 Twister Karabiner (or SH826 snap hook)

Updated 9th April 2018.

Reason for Notice - UPDATE TO Feb. 8 NOTICE

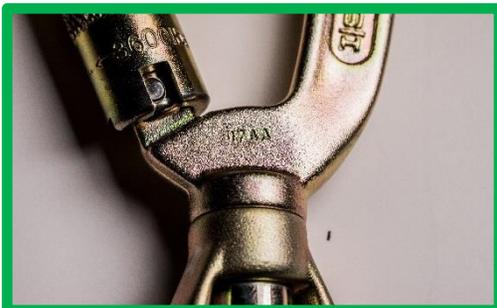
Step 1: Determine the batch number of the KH260 Twister Karabiner.

If the Karabiner has a batch number other than 16CC, no further action is required at this time.

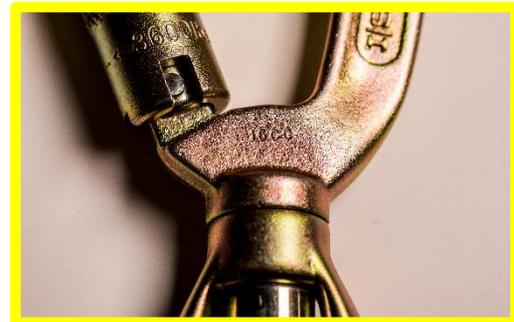
If the Karabiner has the batch number of 16CC, please move to next step.

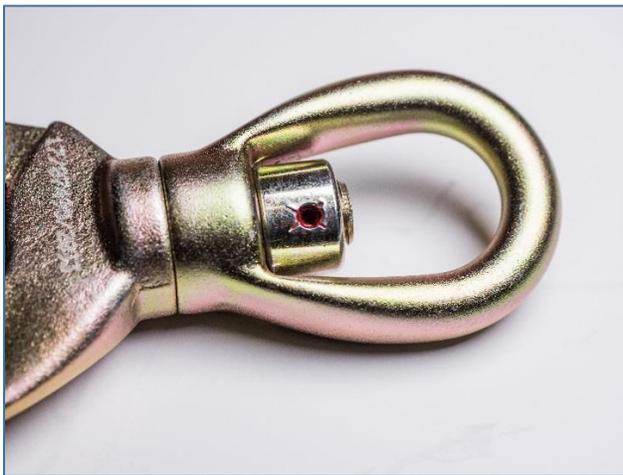
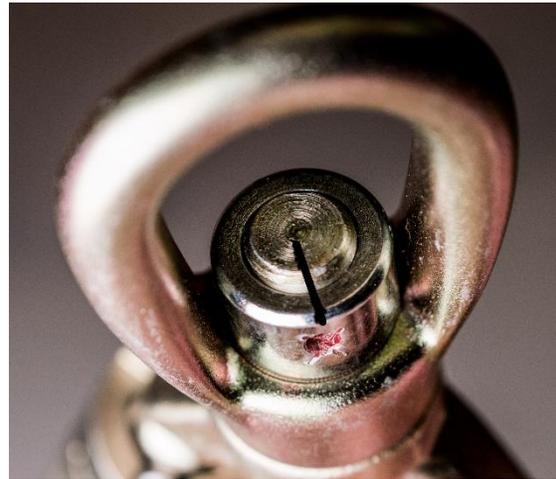
Step 2: Inspect the nut inside the swivel eye of the KH260 Karabiner. You should notice a hole in the nut where the retaining pin is inserted at the factory. You will typically see red indicator paint which is placed in the hole during the manufacturing process. This paint may wear off over time with use.

- 1) Verify presence of the red paint. If the red paint is missing, verify that you can see a roll pin in the hole (C shaped material)
- 2) Customer should permanently mark the top of the stem and nut as shown below. At each inspection verify that the mark is aligned between the stem and nut and does not rotate.

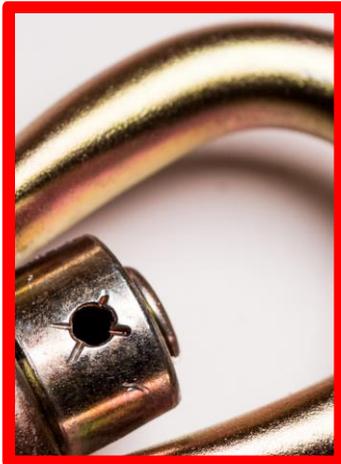
If the roll pin is not visible and/or the nut rotates, remove the karabiner from service immediately.

Please send all affected units back to ISC quoting RMA#763 on all paperwork and boxes. If the KH260 karabiner (or SH826 snaphook) is installed on another manufacturer's device, please contact that manufacturer. We apologize for any inconvenience caused because of this issue.
